## FACE INVESTIGATION

**SUBJECT:** Lineman at Hydroelectric Utility was Asphyxiated when the Safety Rope Attached to his Harness Became Entangled in a Revolving Turbine Shaft.

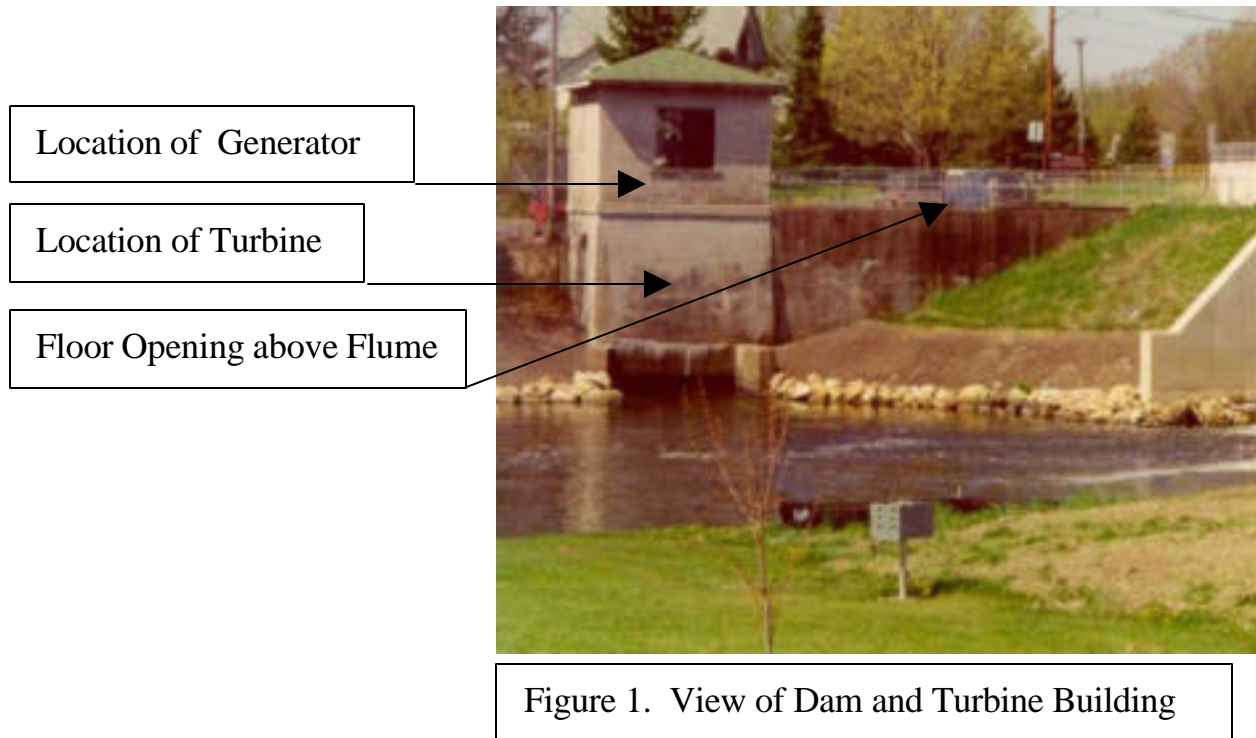
**SUMMARY:** A 34-year-old male lineman (the victim) died of asphyxiation when the safety rope attached to his harness became entangled in a revolving turbine shaft. The victim was employed as a

lineman for the city's hydroelectric utility, and was inspecting a 75-year-old turbine that was idle following replacement of a dam. He was working with a co-worker in the enclosed flume that channeled river water through the turbine. The victim donned a fall protection harness and entered the flume via a ladder lowered from a floor opening in the platform above the flume. His safety rope was held by a co-worker standing on the platform. Another co-worker held the safety rope of the co-worker who was working in the flume with the victim. Although the major portion of the water flow had been blocked off, a small steady stream of water leaked through the control gates and flowed through the area. The knee-high, flowing water struck the turbine vanes which caused the 4 1/4-inch diameter shaft to rotate about 20 rpm. The turbine was tagged out at the utility station, but there was no lockout device to stop the revolution caused by the leaking water stream. After inspecting the area around the turbine, the victim noted that many of the turbine vanes were "frozen" in place, rather than swinging on the bolts which held them in place. He and the co-worker in the flume began striking the vanes with a maul, to break the crust that prevented them from moving. After several strikes, the victim apparently slipped in the water and fell toward the spinning shaft. His safety rope got caught on a shaft coupling, and his harness was pulled tight to the shaft. The victim's body stopped the rotation of the turbine shaft. The co-worker cut the rope after he realized what happened, and called for help up to the two co-workers. The co-workers secured the generator wheel so the victim could be cut loose without the wheel restarting. Emergency services responded, and cut the

- ! install a locking brake which stops the rotation of hydroelectric turbines when maintenance and repair is necessary.**
- ! develop and implement a written hazardous energy control program that includes specific procedures for all machines that could result in a release of hazardous energy**
- ! provide training in the recognition and avoidance of unsafe conditions to workers who are assigned tasks outside their normal duties.**
